Project No. 4622G-5

SEPTIC SYSTEM AND SEEPAGE PIT MONITORING REPORT THE RANCH HOMEOWNER'S ASSOCIATION SEMI-ANNUAL REPORT (JANUARY – JUNE 2008)

Site Address: Clay Station and Tavernor Road
Sacramento County, CA

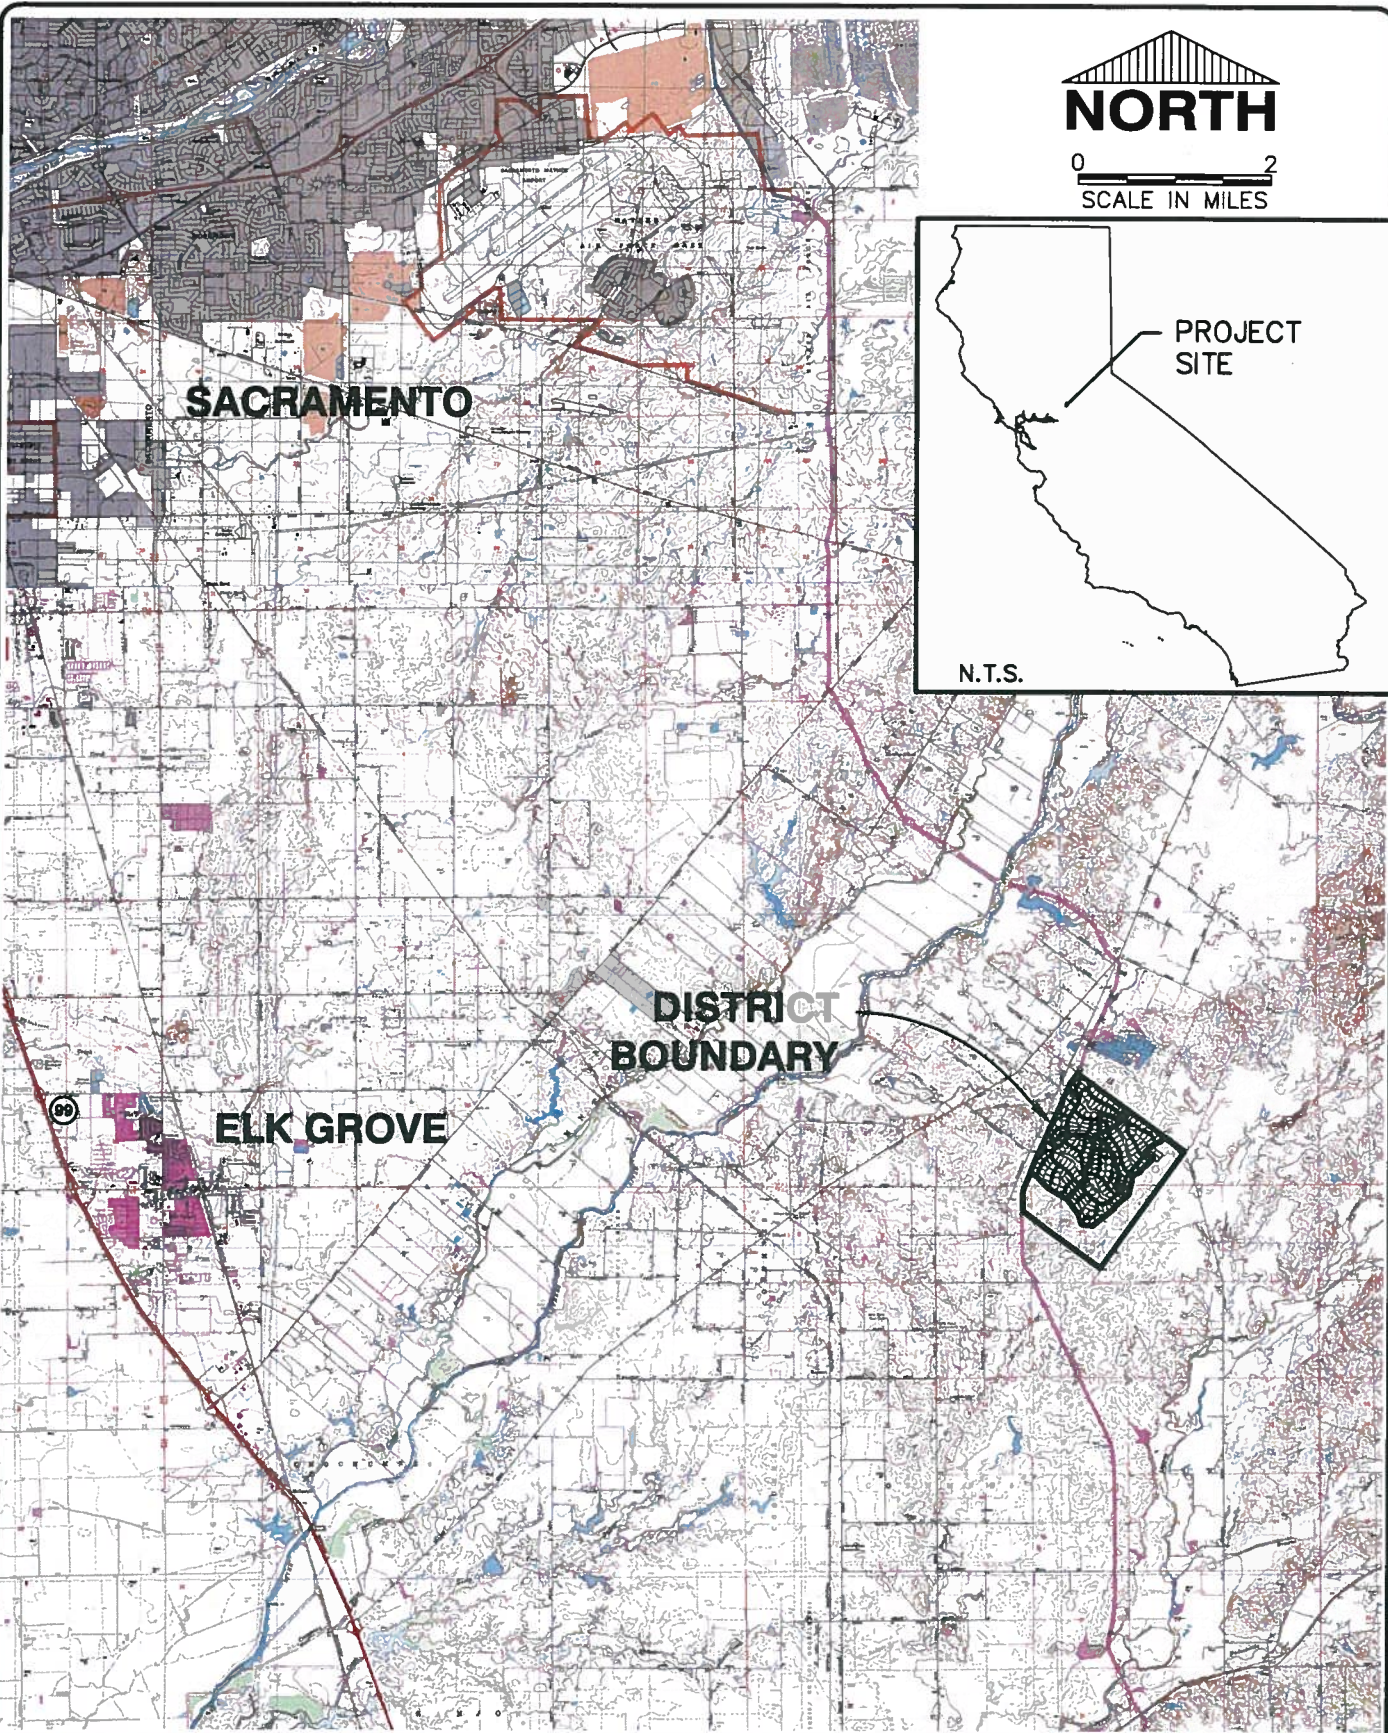
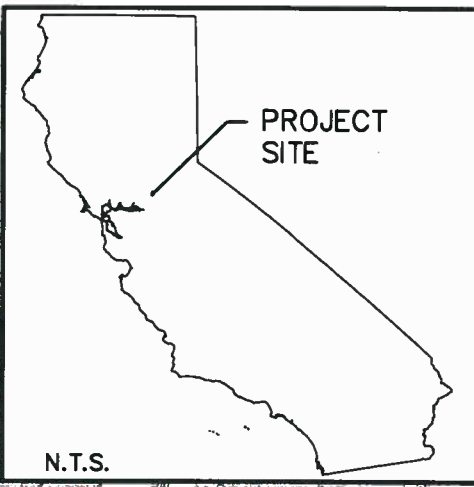
**FIGURE
 1**
 File No.
 4622-3F1

**VICINITY MAP
 THE RANCH
 SEWER MAINTENANCE DISTRICT
 SACRAMENTO COUNTY, CALIFORNIA**

There are currently no leachfields installed at The Ranch. Condor performed visual inspections of seepage pits and made drain rock depth measurements within The Ranch Sewer Maintenance District (District) shown on Figure 1. In conformance with The Ranch Operations and Maintenance Plan, and Regional Board's WDR and MRP, inspections were conducted in the first quarter of 2008 for seepage pits of 193 septic systems constructed in the previous calendar years (2004, 2005, 2006, and 2007). A total of 946 seepage pits were measured for drain rock. The database of 2007 septic systems and current owners is included in Attachment 1 and the seepage pits inspected are listed in Summary Report No. 1 (Attachment 3). Maps of inspected systems are shown on Figures 2A, 2B and 2C. Condor representatives followed routine procedures described in *Septic Tank Inspection and Seepage Pit Sampling Procedures*, Attachment 2. Field forms (Attachment 2) were used to collect data during pit inspections in 2008; the data was later entered into a database. Forms used for collection of data are provided in Attachment 2.
